**Flood Control Project Maintenance
Levee Inspections**

Maintenance Issue Types Only, Levee Inspection Report By Mile - Fall 2018

Sutter Maintenance Yard Tisdale Bypass

Waterway	Bank	Unit Miles	Inspection Start/End	Inspector
Unit No. 01 Tisdale Bypass	Left	4.51	10/03/2018 10/03/2018	Bob Duffey

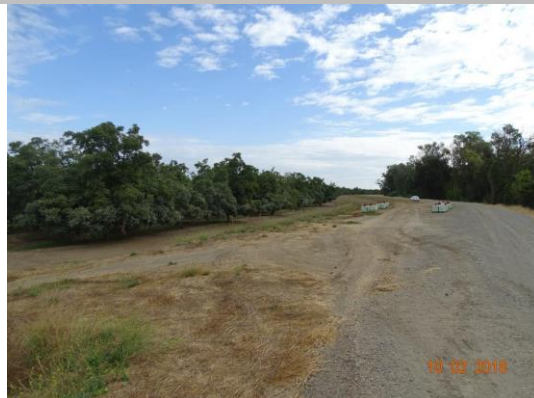
Photo 1 of 1 : FA_2018_ST0009_286_11_20181008_00019.jpg

LM Start	0.02	Rating **	A	Issue No.	11
LM End	0.71	Issue Type +	Ma	Location *	LS
Category	Earthen Levee			GPS Latitude/Longitude	
				Start	End
Item	Vegetation			39.027172°	39.028325°
				-121.821437°	-121.808907°
DWR ID	DWR_ST0009_01_f_2018_11				
Comment Code					
V1 : Control annual grass and weeds on the levee slopes and easements.					
Inspector Comment					
The vegetation was removed from the landside slope.

View of the removed vegetation from the landside slope.

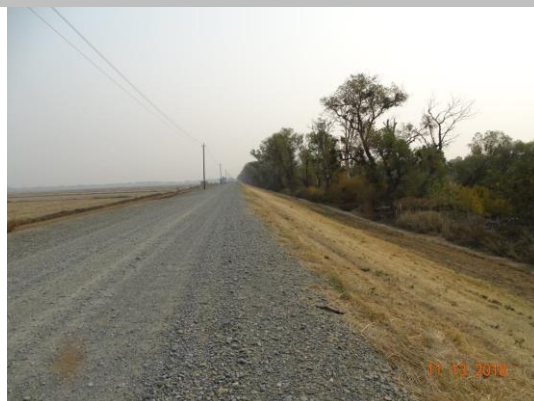
Photo 1 of 2 : FA_2018_ST0009_286_10_20181114_00024.jpg

LM Start	0.02	Rating **	A	Issue No.	10
LM End	4.50	Issue Type +	Ma	Location *	WS
Category	Earthen Levee			GPS Latitude/Longitude	
				Start	End
Item	Vegetation			39.027172 °	39.032885 °
				-121.821437 °	-121.743387 °
DWR ID	DWR_ST0009_01_f_2018_10				
Comment Code					
V2 : Remove the wild growth other than native grasses from the levee slopes.					
Inspector Comment					
The vegetation was mowed or burned along the waterside slope.

View of the mowed or burned vegetation along the waterside slope.

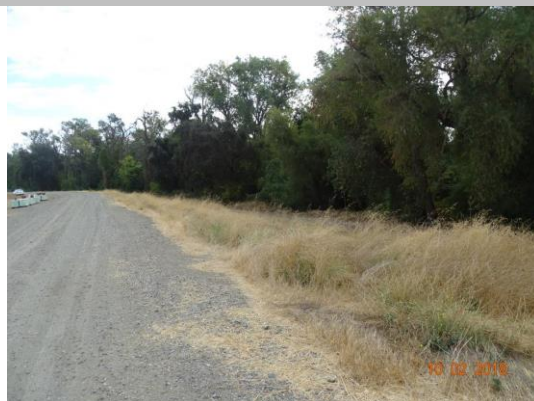
Photo 2 of 2 : FA_2018_ST0009_286_10_20181008_00020.jpg

View of the vegetation along the waterside slope.

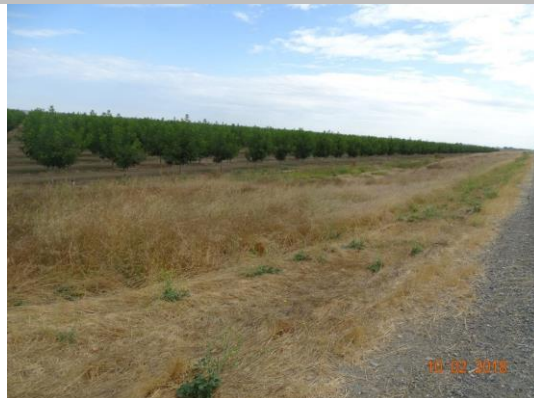
Photo 1 of 1 : FA_2018_ST0009_286_15_20181008_00021.jpg

LM Start	0.71	Rating **	A	Issue No.	15
LM End	1.44	Issue Type +	Ma	Location *	LS
Category	Earthen Levee			GPS Latitude/Longitude	
				Start	End
Item	Vegetation			39.028325 °	39.028257 °
				-121.808907 °	-121.795252 °
DWR ID	DWR_ST0009_01_f_2018_15				
Comment Code					
V2 : Remove the wild growth other than native grasses from the levee slopes.					
Inspector Comment					
The vegetation was mowed or burned along the landside slope.

View of the vegetation along the landside slope.

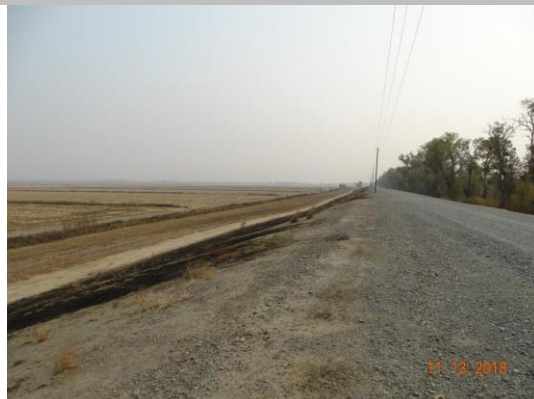
Photo 1 of 2 : FA_2018_ST0009_286_16_20181114_00023.jpg

LM Start	2.00	Rating **	A	Issue No.	16
LM End	4.50	Issue Type +	Ma	Location *	LS
Category	Earthen Levee			GPS Latitude/Longitude	
				Start	End
Item	Vegetation			39.028183 °	39.032885 °
				-121.785020 °	-121.743387 °
DWR ID	DWR_ST0009_01_f_2018_16				
Comment Code					
V2 : Remove the wild growth other than native grasses from the levee slopes.					
Inspector Comment					
The vegetation was burned or mowed along the landside slope.

View of the burned or mowed vegetation along the landside slope.

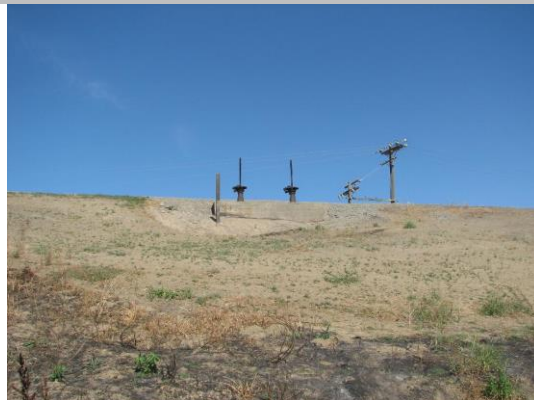
Photo 1 of 3 : UCIP_FA_2018_51484_64226.jpg

Comment Code					
Inspector Comment					
FS_ID:51484 DS_ID:16591 EP_NO: 10099 Repair Type: No Action Needed Crossing Status: Found UCIP Comments: 4/10/2017 Crossing appears to be in good condition. (DWR Sutter Yard- A Freitag)10/11/2016 Crossing appears to be in good conditon.(DWR Sutter Yard - a Freitag)4/18/2016 Crossing appears to be in good condition. No noticeable issues to report.5/7/2015 Crossing is in good condition. No noticeable issues to report.11/13/2014 Same as last inspection.5/12/2014 Same as last inspection.10/30/2013 Same as last inspection.5/20/2013 Same as last inspection. FIELD_STRUCT_DESC: 1 of 2: 4-foot by 7-foot reinforced concrete discharge tunnel through the levee, 38 feet below the crown. Slide gate in 4-foot by 15-foot concrete well on the waterside (WS) slope. Pump house located on the landside (LS) toe and wooden flap gates on the WS toe. (two 4-foot by 7-foot tunnel [HLM 2.13] authorized under Automatic Board Order (ABO) issued as Permit No. 10099, 1955 - Reclamation District No. 1660). [Additional Reference(s): DWR Levee Log, 1993. USACE Sacramento O&M Manual 133, August 1955 (Station 1044+60)]. FS Date: 4/12/2017 9:20:05 AM

Slide gates on WS shoulder.

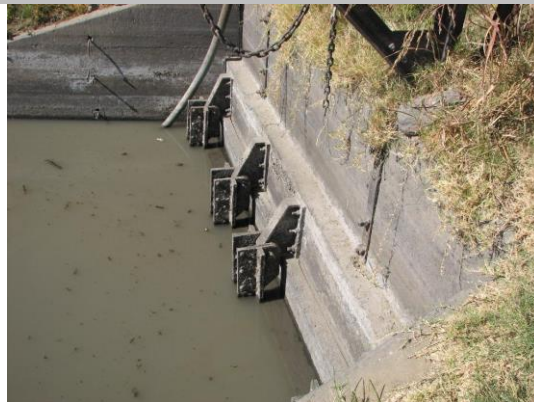
Photo 2 of 3 : UCIP_FA_2018_51484_64225.jpg

Wooden Flap gates on WS toe.

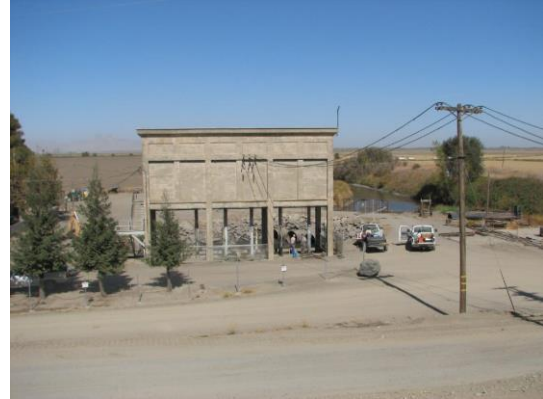
Photo 3 of 3 : UCIP_FA_2018_51485_64228.jpg

Pump house on LS toe.

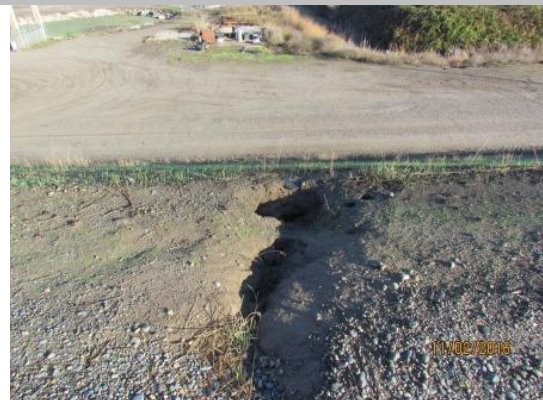
Photo 1 of 2 : FA_2018_ST0009_286_12_20180905_00002.jpg

LM Start	2.16	Rating **	U	Issue No.	12
LM End	2.16	Issue Type +	Ma	Location *	LS
Category	Earthen Levee			GPS Latitude/Longitude	
				Start	End
Item	Animal Control			39.028137°	39.028137°
				-121.782020°	-121.782020°
DWR ID	DWR_ST0009_01_f_2016_12				
Comment Code					
A3 : No rodents visible, but rodent burrows visible; need to backfill and compact or grout burrows.					
Inspector Comment

View of a rodent hole along the levee crown.

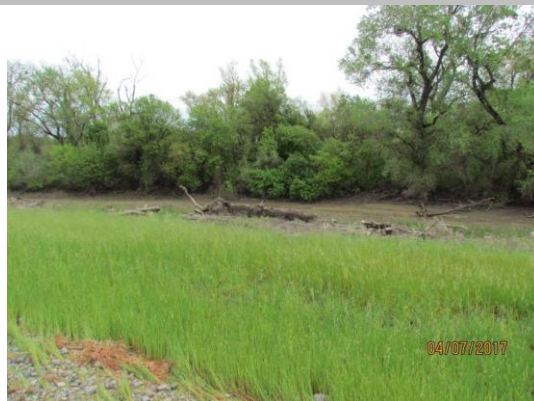
Photo 1 of 1 : FA_2018_ST0009_286_24_20180905_00004.jpg

LM Start	4.35	Rating **	M	Issue No.	24
LM End	4.35	Issue Type +	Ma	Location *	WS
Category	Earthen Levee			GPS Latitude/Longitude	
				Start	End
Item	Encroachments			39.030637 °	39.030637 °
				-121.743023 °	-121.743023 °
DWR ID	DWR_ST0009_01_s_2017_24				
Comment Code					
DE : Debris					
Inspector Comment					
Remove the debris from the waterside slope and toe.

View of the debris along the waterside slope and toe.

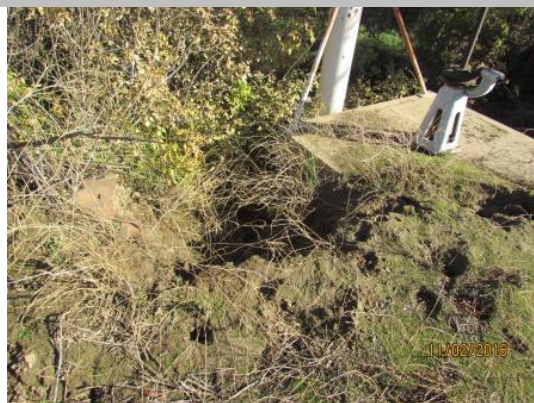
Photo 1 of 2 : FA_2018_ST0009_287_13_20180905_00007.jpg

LM Start	1.14	Rating **	M	Issue No.	13
LM End	1.14	Issue Type +	Ma	Location *	WS
Category	Earthen Levee			GPS Latitude/Longitude	
				Start	End
Item	Erosion / Bank Caving			39.025460 °	39.025460 °
				-121.800022 °	-121.800022 °
DWR ID	DWR_ST0009_02_f_2016_13				
Comment Code					
E2 : Schedule repair of erosion site prior to the next inspection.					
Inspector Comment					
Erosion around the WS concrete vault.

View of the erosion along the concrete vault.

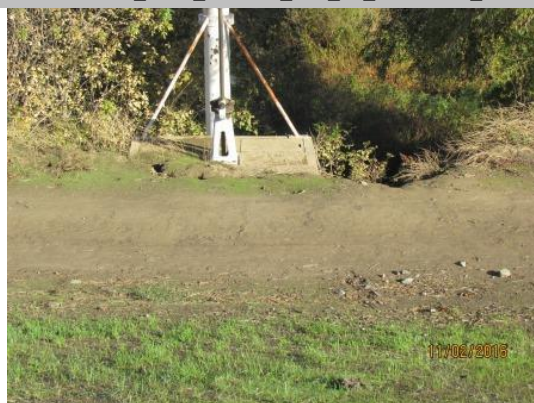
Photo 2 of 2 : FA_2018_ST0009_287_13_20180905_00008.jpg

Another view of the erosion along the concrete vault.

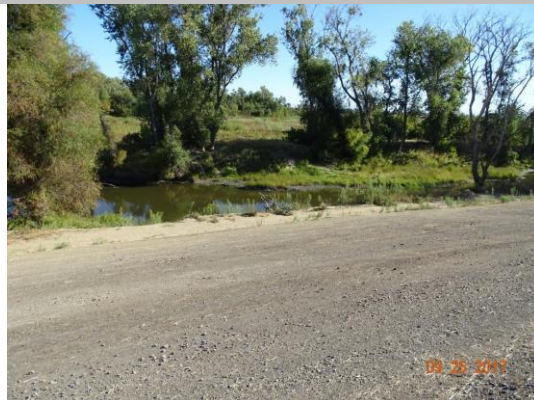
Photo 1 of 1 : FA_2018_ST0009_287_18_20180905_00009.jpg

LM Start	4.09	Rating **	A/W	Issue No.	18
LM End	4.09	Issue Type +	Ma	Location *	WS
Category	Earthen Levee			GPS Latitude/Longitude	
				Start	End
Item	Erosion / Bank Caving			39.024912 °	39.024912 °
				-121.745237 °	-121.745237 °
DWR ID	DWR_ST0009_02_f_2017_18				
Comment Code					
E2 : Schedule repair of erosion site prior to the next inspection.					
Inspector Comment					
Repair the erosion along the water side berm.

View of the erosion along the waterside berm.
